# Cavelero Creek

# “Small Stream Study”

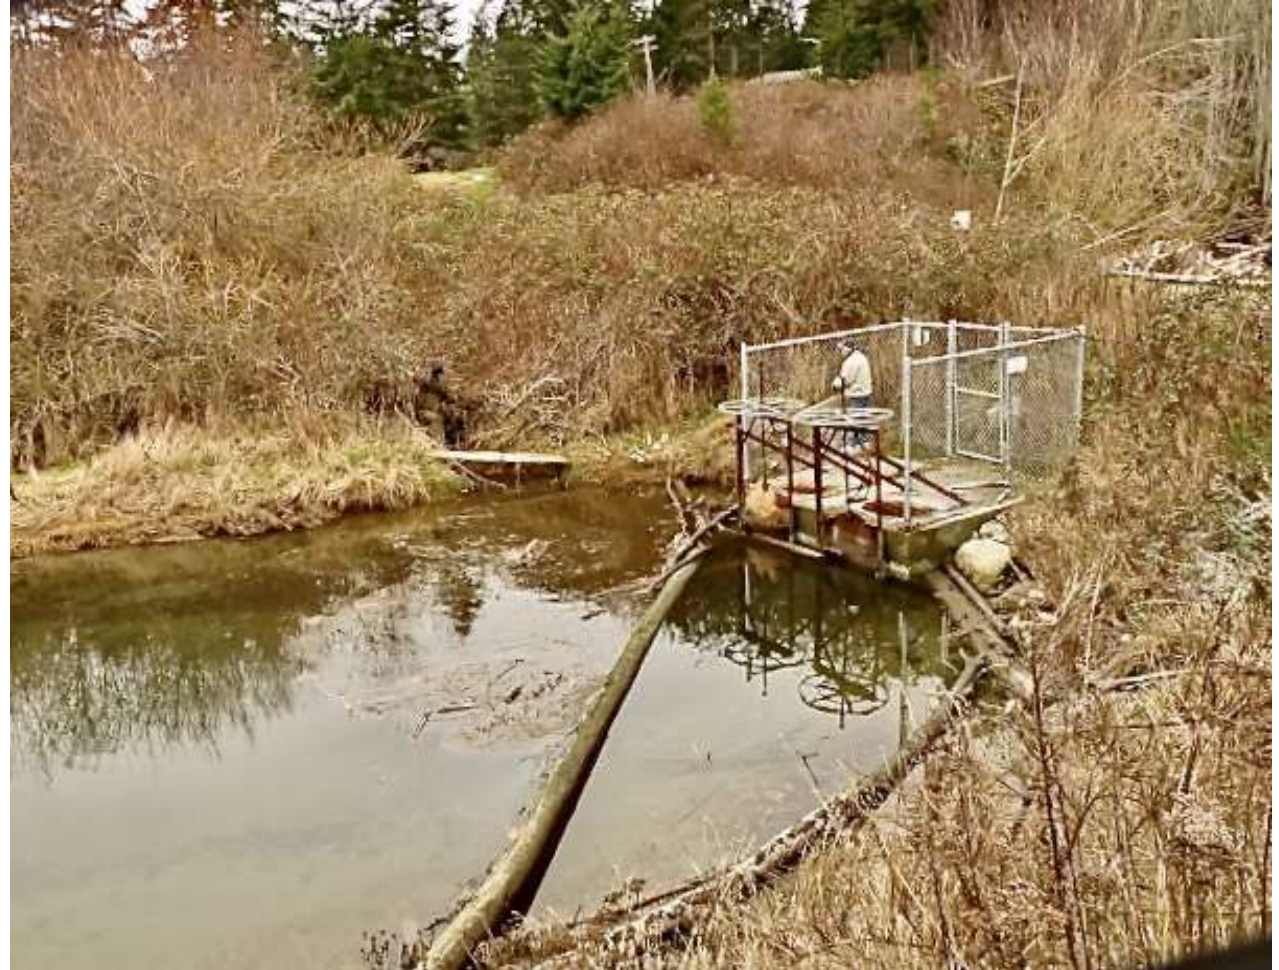
In 2010, as part of the “Small Stream Study”, the Tulalip Tribe completed a 10 week electrofishing Survey of the lower 200 feet of Cavelero Creek (referred to as Country Club Creek in the Survey). The Survey started where the Creek empties into the Country Club Lagoon just upstream of the tide gate (under plank in center left). The Survey continued upstream approximately 2/3 of the way to where Cavelero Creek passes under Country Club Drive.

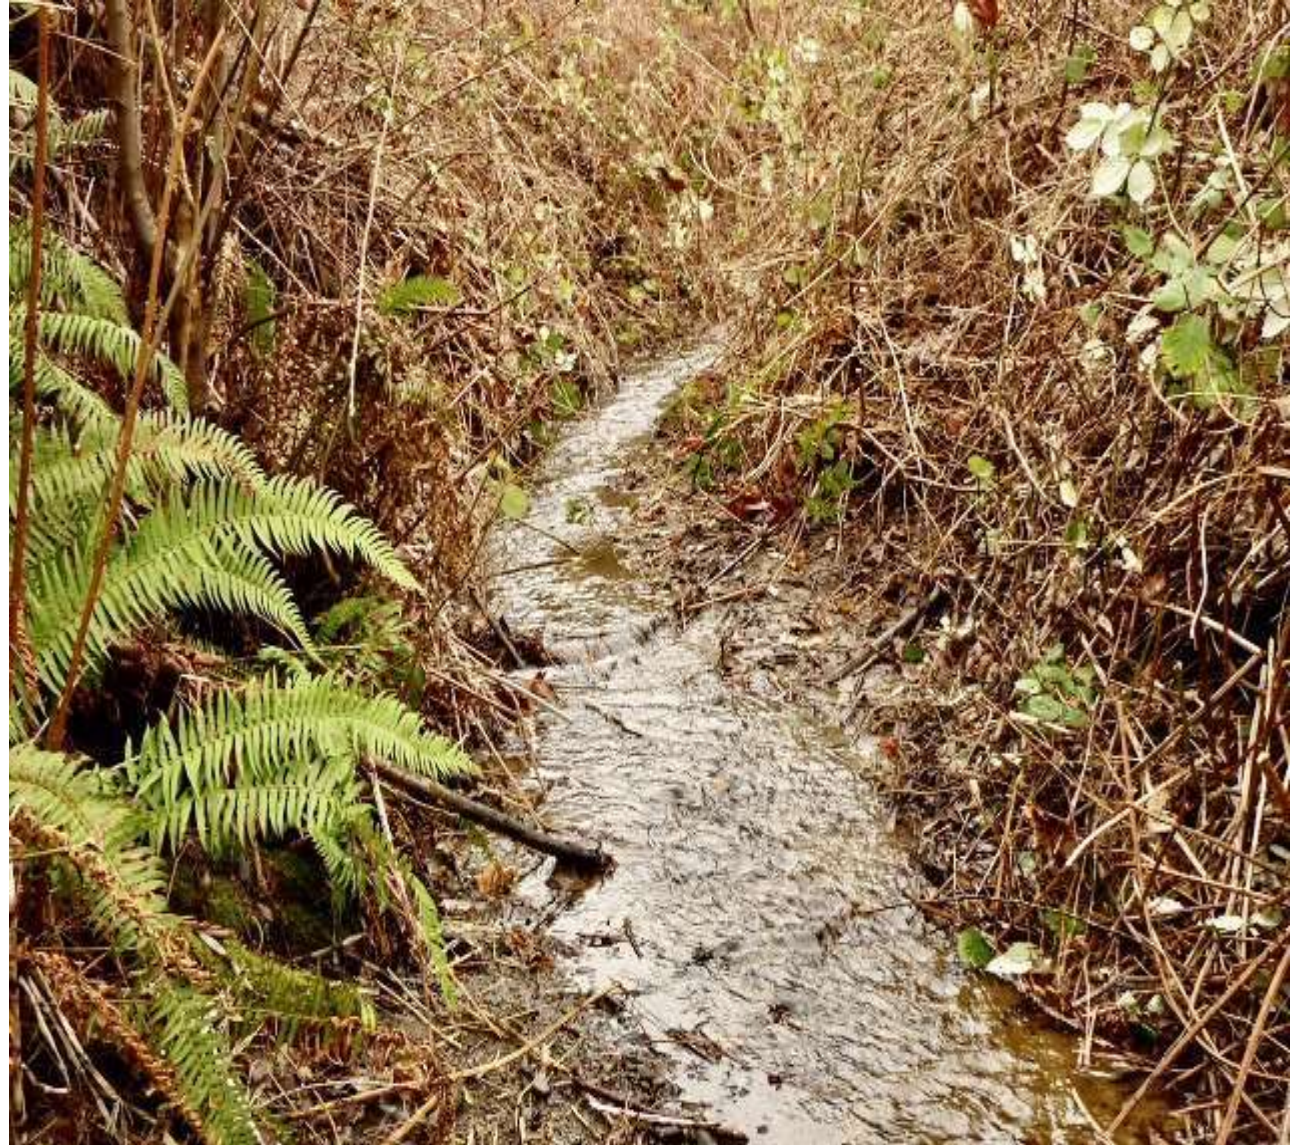
# Cavelero Creek Revealed

As part of the 2010 Survey, blackberry vines were cut back, revealing Cavelero Creek. In spite of the added challenge of navigating the tidegate, numerous juvenile salmonid were sampled in the Creek. Weekly sampling over a 10 week period February – June found a total of:

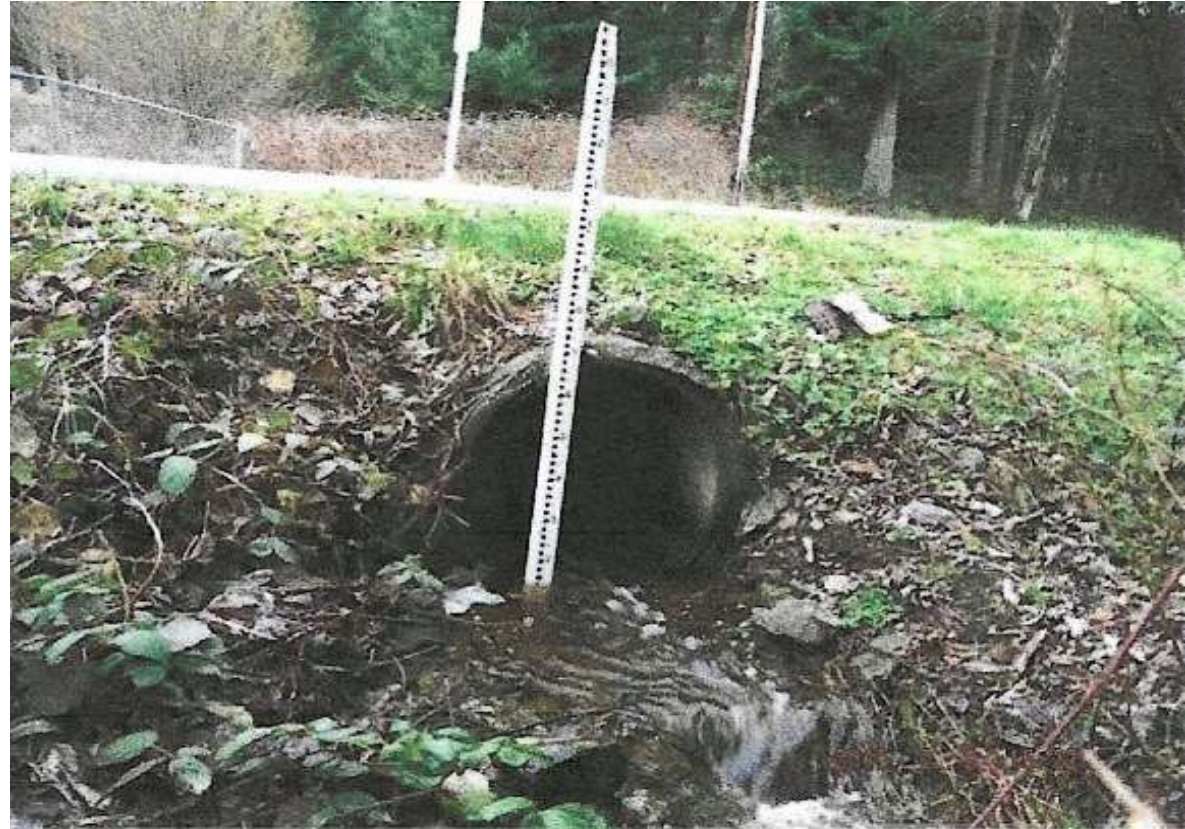
# “Fish Passage Barrier Inventory”

The “Island County Fish Passage Barrier Inventory” conducted in 2015 found the existing 24 inch culvert not adequate for salmonid passage because of the culvert slope where Cavelero Creek crossed under Country Club Drive. The culvert was listed as a priority to be upgraded.

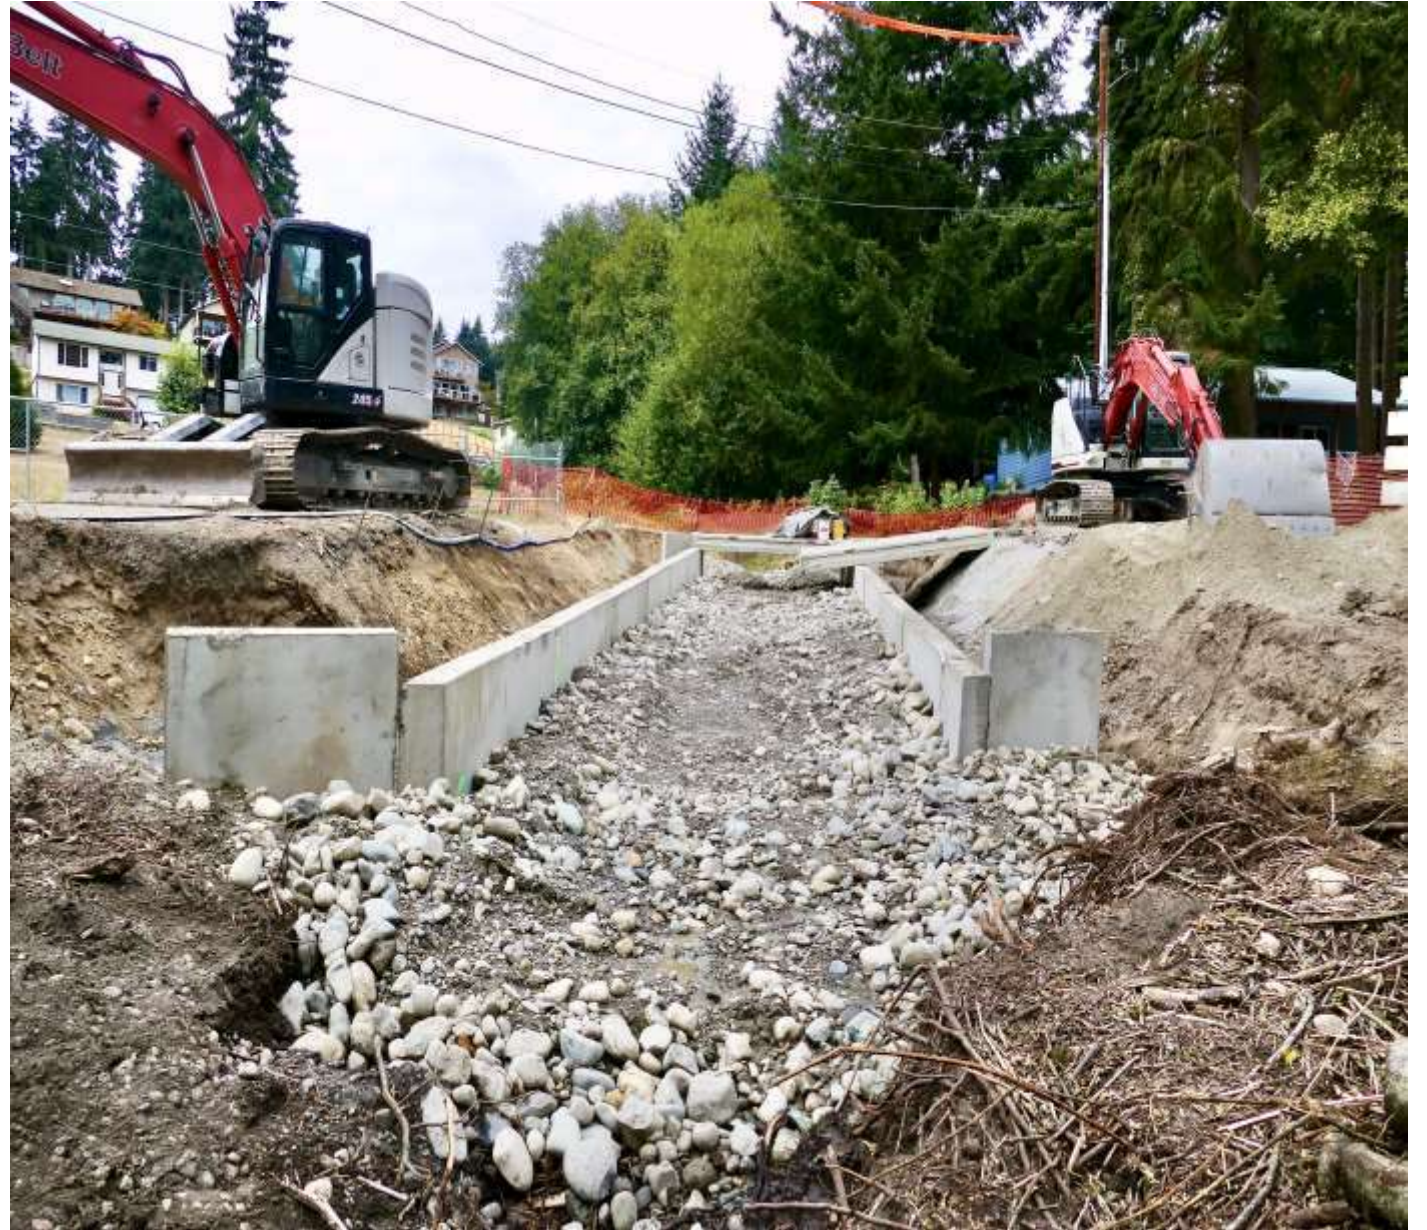
# Under Construction

In September 2021, a salmon friendly box culvert was installed. Construction was completed during the very lowest water flow and at a time least likely to impact fish. Any possible water was temporarily diverted, the stream bed excavated, a multipart concrete box culvert installed, and a fish friendly gravel substrate was installed and graded to encourage natural water flow.

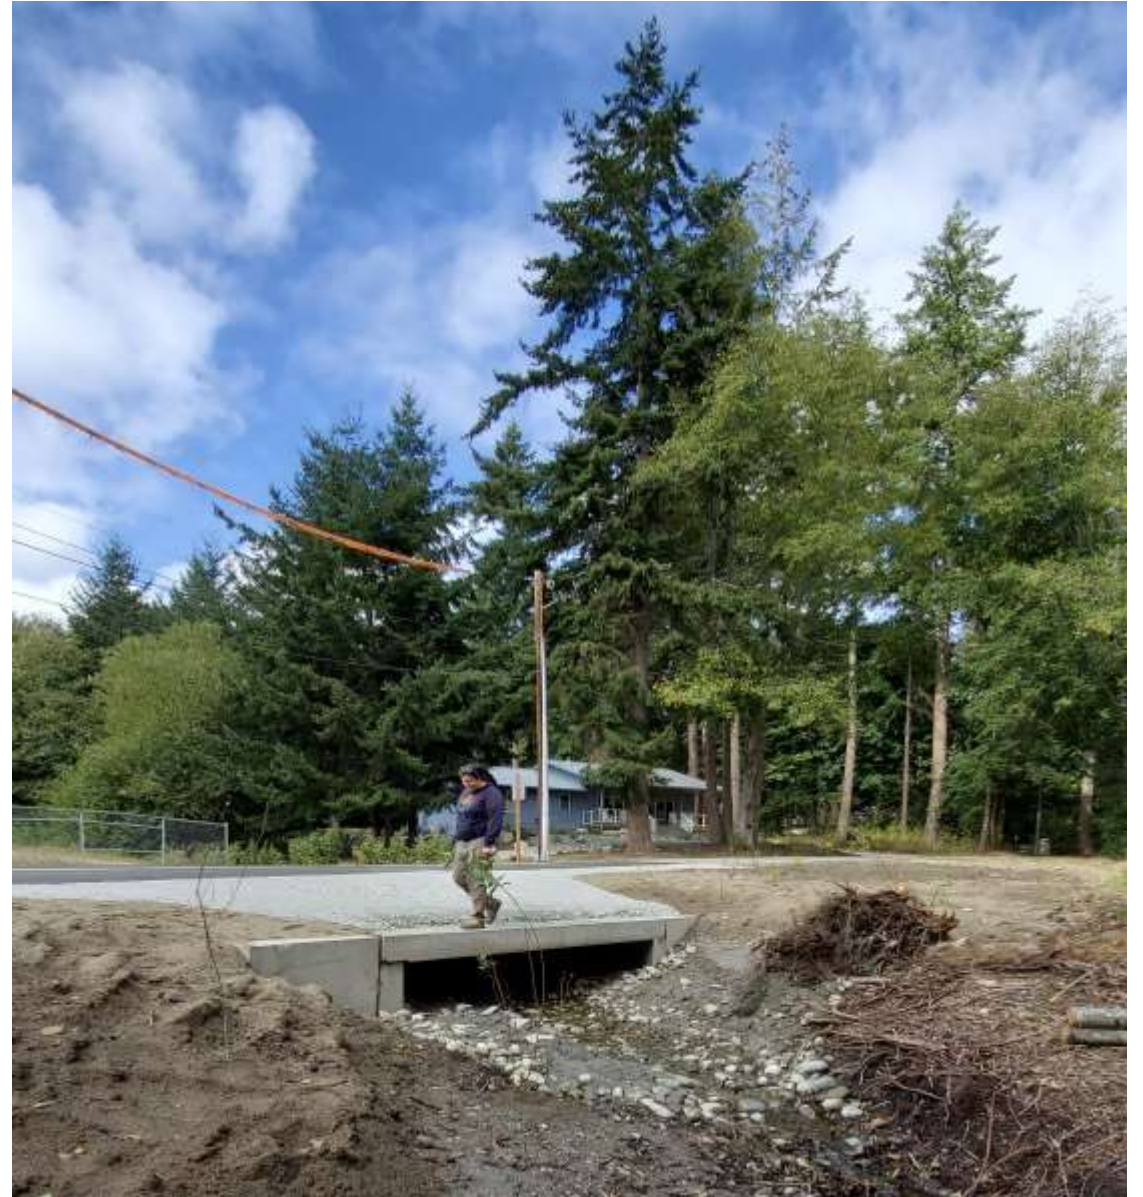
# Improved Fish Passage

The top panels of the new box culvert were installed, and the road grade restored. Native plants were installed along the stream banks and the stream flow was then redirected to the new stream bed. This much improved passage will enable salmonids to better access upstream rearing habitat.
